# CHICAGO FIRE

OF MARCH 15, 1922

EMBRACING C. B. & Q. R. R. CO.  
OFFICE BUILDING

By CHICAGO BOARD OF UNDERWRITERS

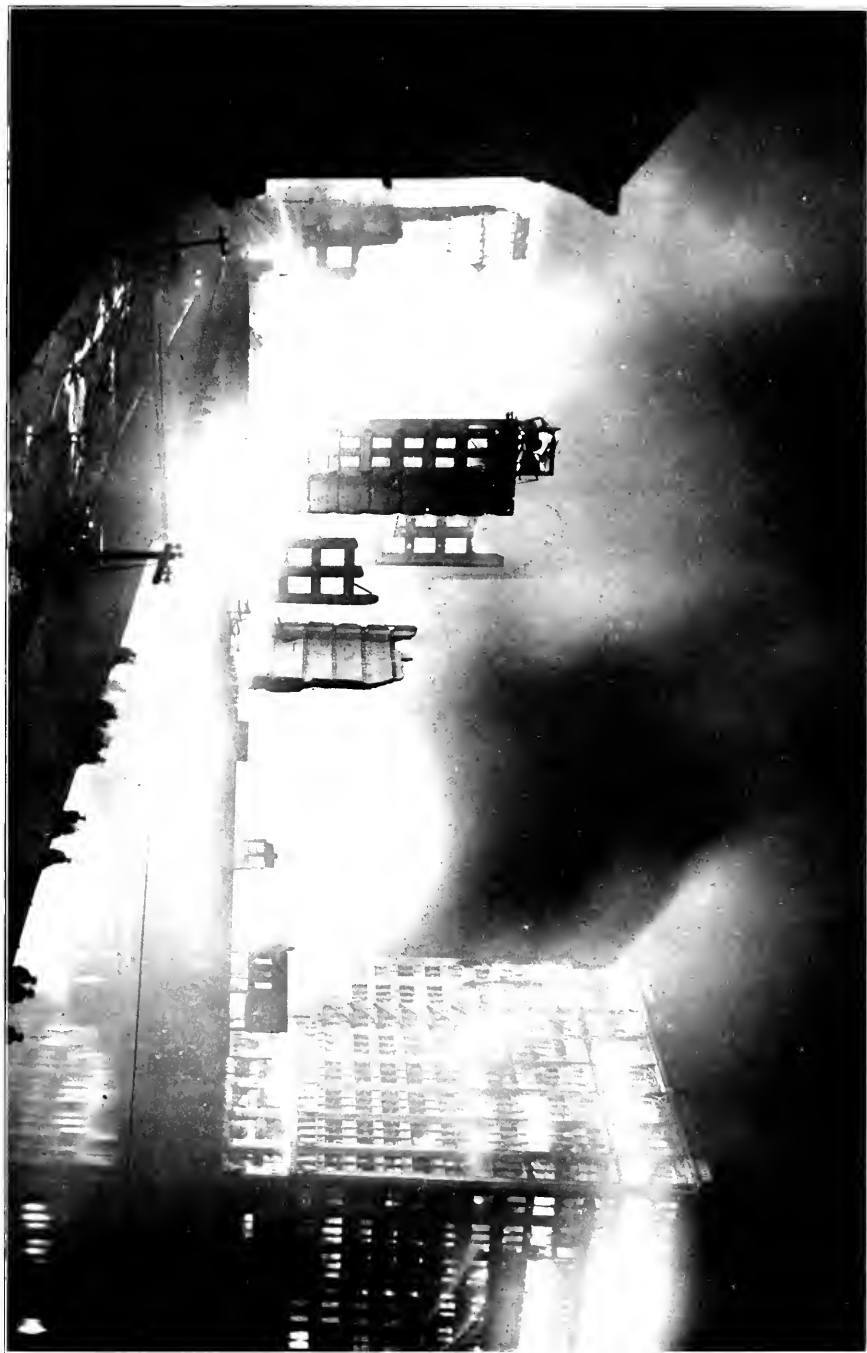
FIG. 1A.  
BURNING BUILDINGS AT 2:45 A. M. BURLINGTON BUILDING AT RIGHT.  
(PHOTO BY DAILY NEWS)

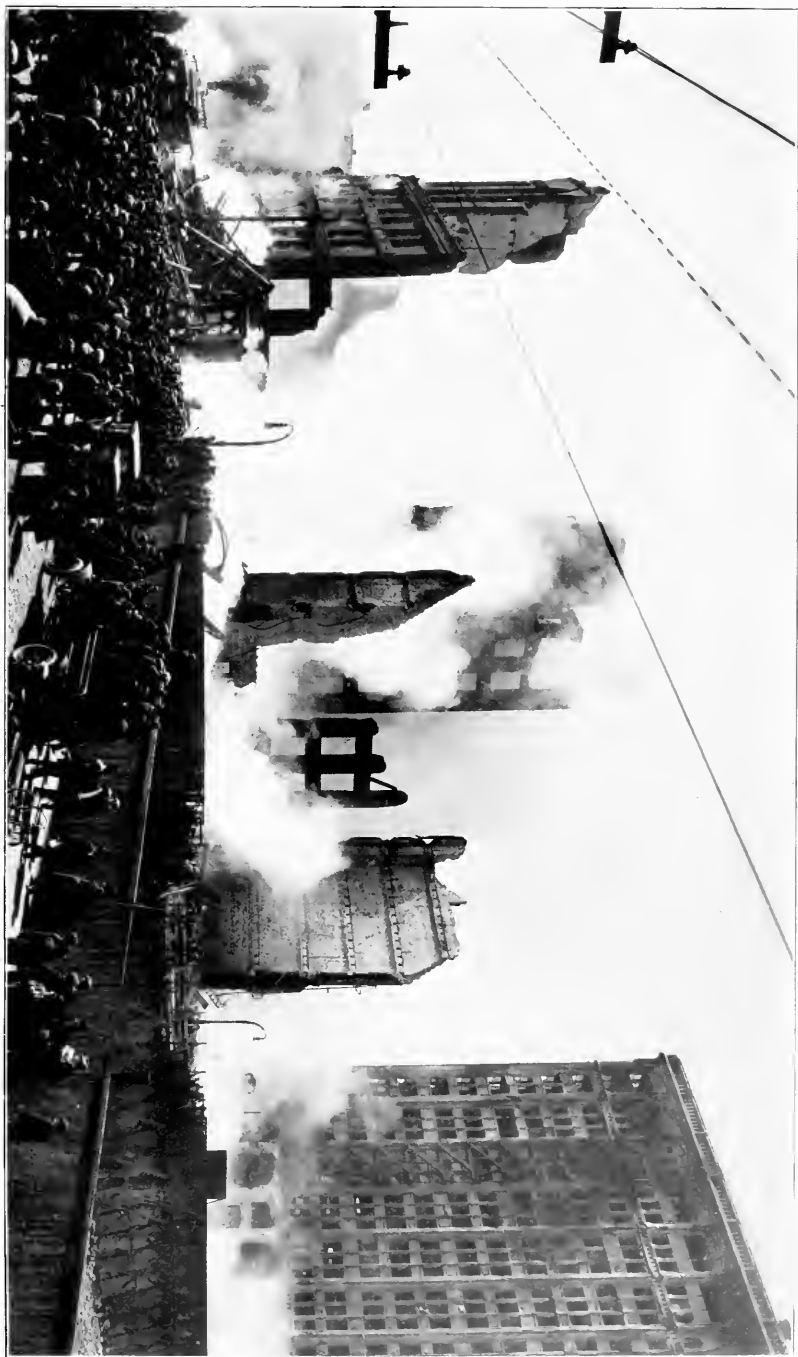
FIG. 1B.  
PRINCIPAL BUILDINGS DESTROYED OR DAMAGED, LOOKING SOUTH.  
(PHOTO BY INTERNATIONAL)

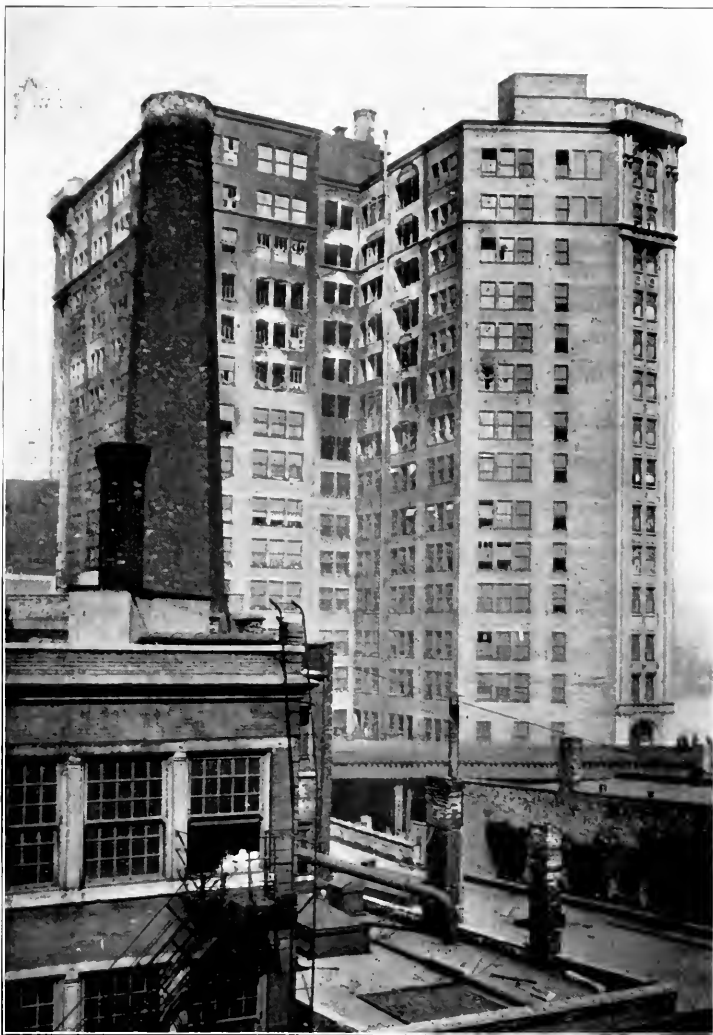
Fig. 4.  
REAR ELEVATION OF BURLINGTON BUILDING.

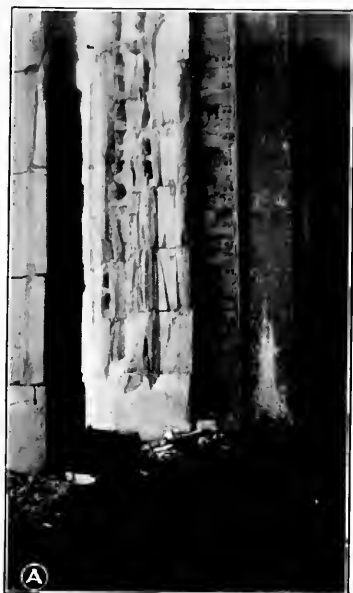
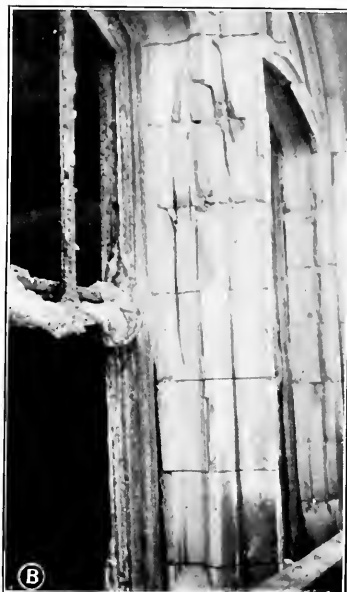
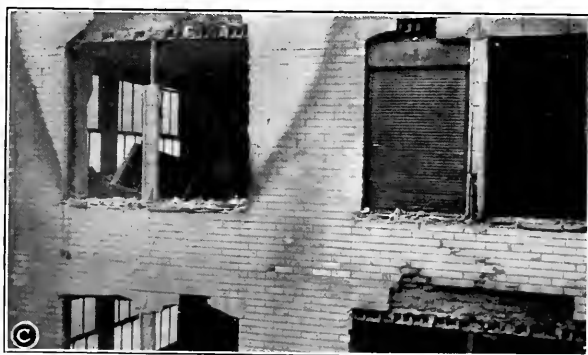
Fig. 5.

- A. SHOWING HOLLOW BRICK PROTECTION ON EXTERIOR COLUMN, AND DAMAGE TO TERRA COTTA.
- B. DAMAGED TERRA COTTA; WIRED GLASS WINDOW AT EAST FIRE ESCAPE.
- C. ROLLING STEEL SHUTTER ON VENTILATING FAN INTAKE.

Ornamental mat glazed terra-cotta facing was used on north and east walls; glazed terra-cotta bricks on south and west walls and in court. There was damage to this material on all four sides of the building, the heaviest damage occurring in east wall, and in the court walls. Figures 5 and 6 indicate the amount of spalling that took place, but it is believed that some of this damage may be attributed to falling sash weights. In addition to the spalling, the blocks that were most exposed were badly checked; the checks, in several blocks examined, extending through the blocks.

Labeled wired glass windows were installed in openings in south and west walls, and in three openings each floor above first at fire escape, east wall. Those in east wall were intact below the 9th floor, the ones above suffering in varying degrees, but generally softening and running out of frames onto sills, or dropping over steam radiators located just below the sills. Those in west wall, above the 9th floor, experiencing even greater heat, behaved in the same manner permitting flames to lap up the wall and damage the terra-cotta brick facing. **Also see Vertical Shafts.**

This was, as stated in construction details, principally hollow brick on exterior columns, and crushed tile concrete on interior columns. The protection in all cases was intact, even the  $\frac{3}{4}$ -inch plaster finish remaining on some columns. Tile, enclosing pipes run alongside column protection, was mainly destroyed; pipe channels were stopped at floors. At several points where steel had been exposed, after the fire, for the purpose of examination, it was found to be in an excellent state of preservation and condition. Chief Buckley, who made an examination of this kind less than eight hours after the start of fire on a column which had been severely exposed, reported steel as being only slightly warm. Temperatures were sufficient to spall off porcelain and melt the brass in flush type wall switches which were mounted on these columns.

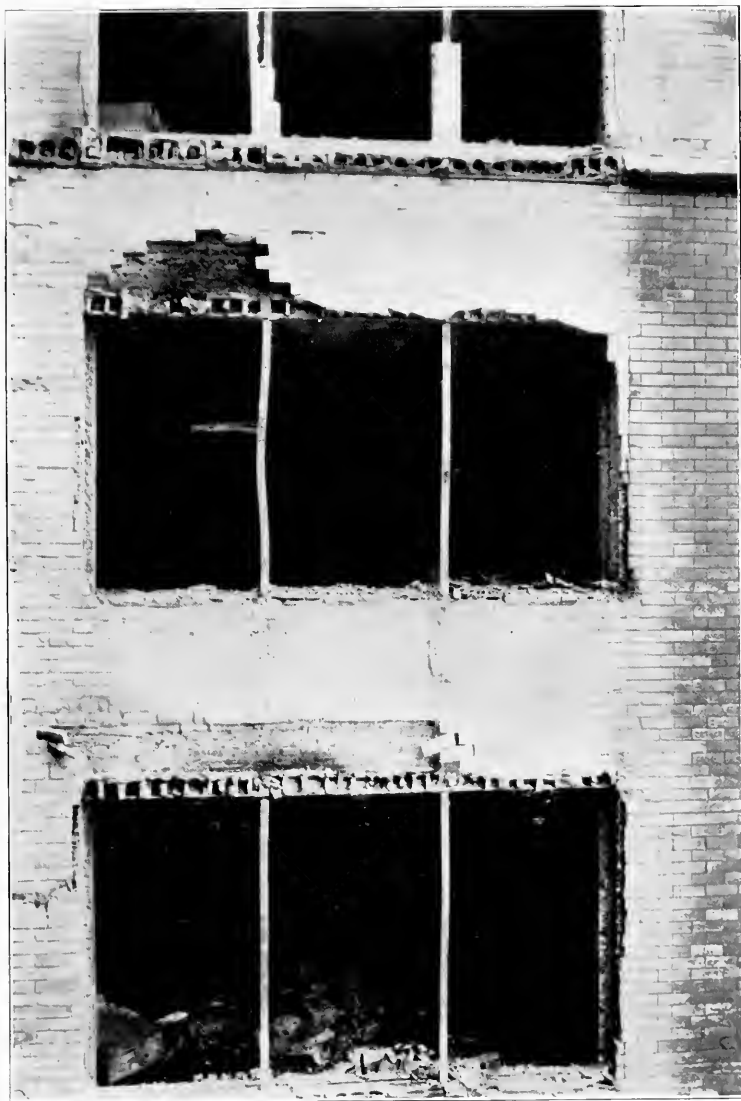
Fig. 6.  
EAST WALL OF COURT, 13TH, 14TH AND 15TH FLOORS. NOTE DAMAGE TO TERRA  
COTTA BRICK.

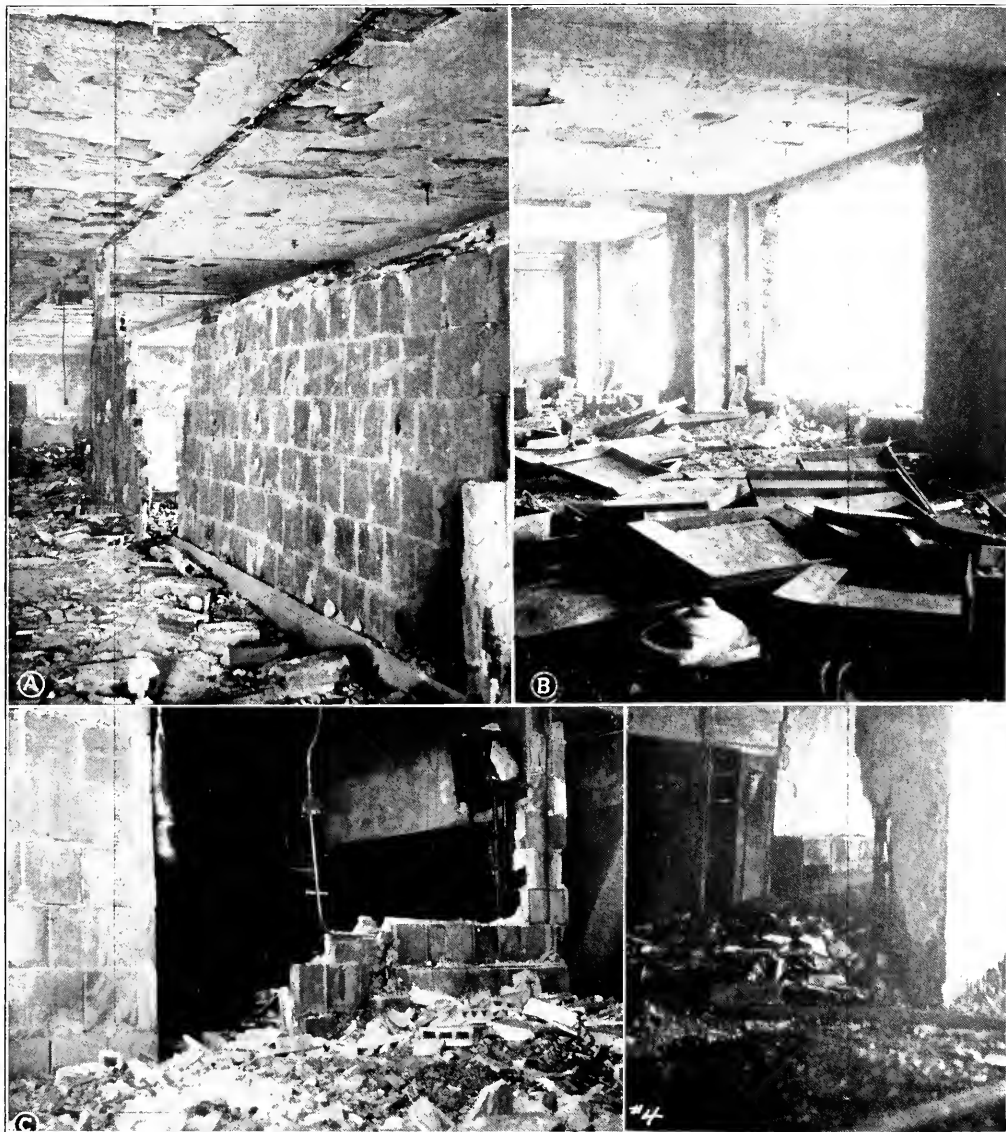
Fig. 7.

- A. SHOWING DAMAGE TO HOLLOW TILE PARTITION AND PLASTERED CEILING.
- B. METAL FILING CABINETS.
- C. VENTILATING FAN ROOM.
- 4. INTERIOR COLUMN AT RIGHT; DAMAGED PORTION IS PIPE ENCLOSURE.

There were no plaster block partitions in this building. All partitions were 3-inch hollow-tile laid on the cinder concrete fill on tile floor arches with no bracing except wooden door frames. Nearly all of these failed, due principally to bulging, which was so great that some sections fell out and others were pulled down by firemen as a measure of safety to themselves.

The metal furniture in use consisted principally of filing cabinets and proved absolutely no protection for the combustible contents which were ignited either by direct flame or excessive heat. The weight of records, together with the heat, caused the cases to buckle and fail at the welded joints. See Figure 7 (b).

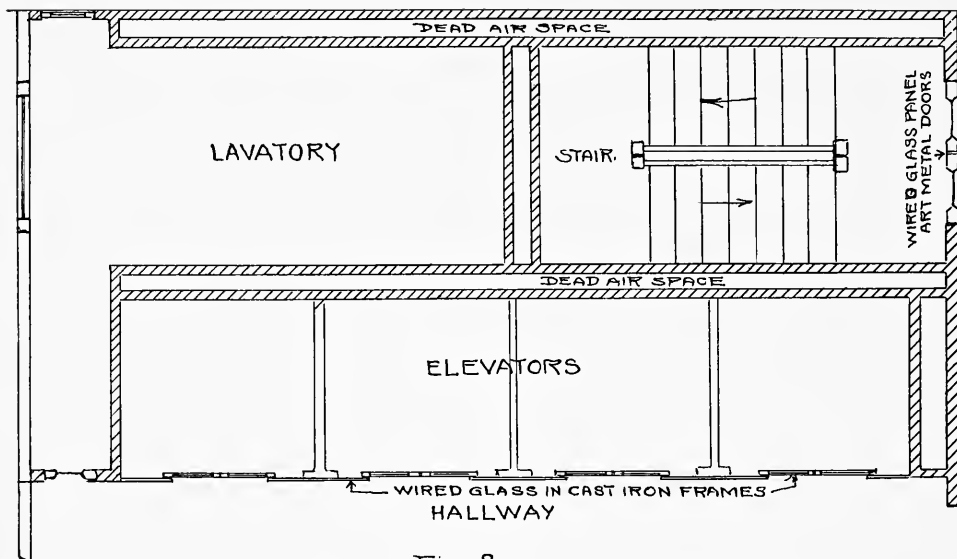
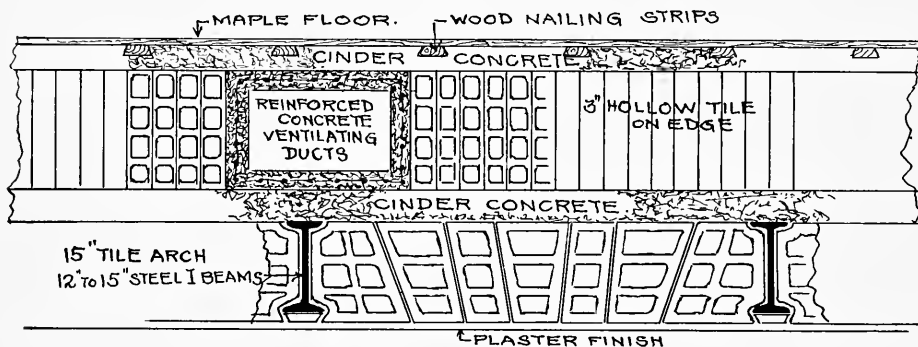
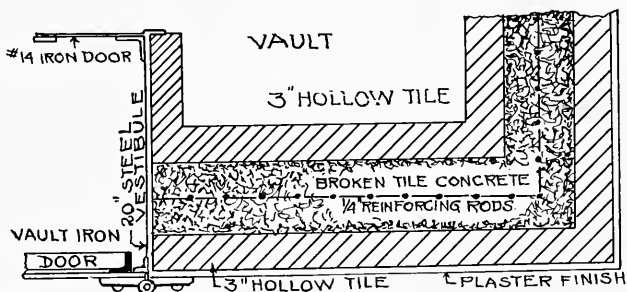
- A. SHOWING CONSTRUCTION OF MAIN STAIR SHAFT AND ELEVATOR BANK.
- B. TYPICAL FLOOR CONSTRUCTION WHERE VENTILATING DUCTS WERE INCLUDED.
- C. TYPICAL VAULT CONSTRUCTION.

The stair enclosures, which were 3-inch tile with wired glass panel art metal (labeled corridor) doors, held very well. The stair in southeast corner of building showed no sign of failure except on top floors where several transom lights failed; there was evidently a cold draught up this stair as wired glass that had softened slightly was bulged toward interior of building and the variation of temperature was evidenced by the fact that the outer surface of the glass had sagged and run in places, while the inner surface was intact. The main stair shaft did not fare quite so well, numerous wired glass panels failing entirely. However, the hand-rails, which was the only combustible material present, were scorched on only two floors. This stair was used by the department in fighting the fire.

In some cases the outer surface of tile spalled off, and in all cases the doors warped, but there was no evidence of any heat inside the vaults.

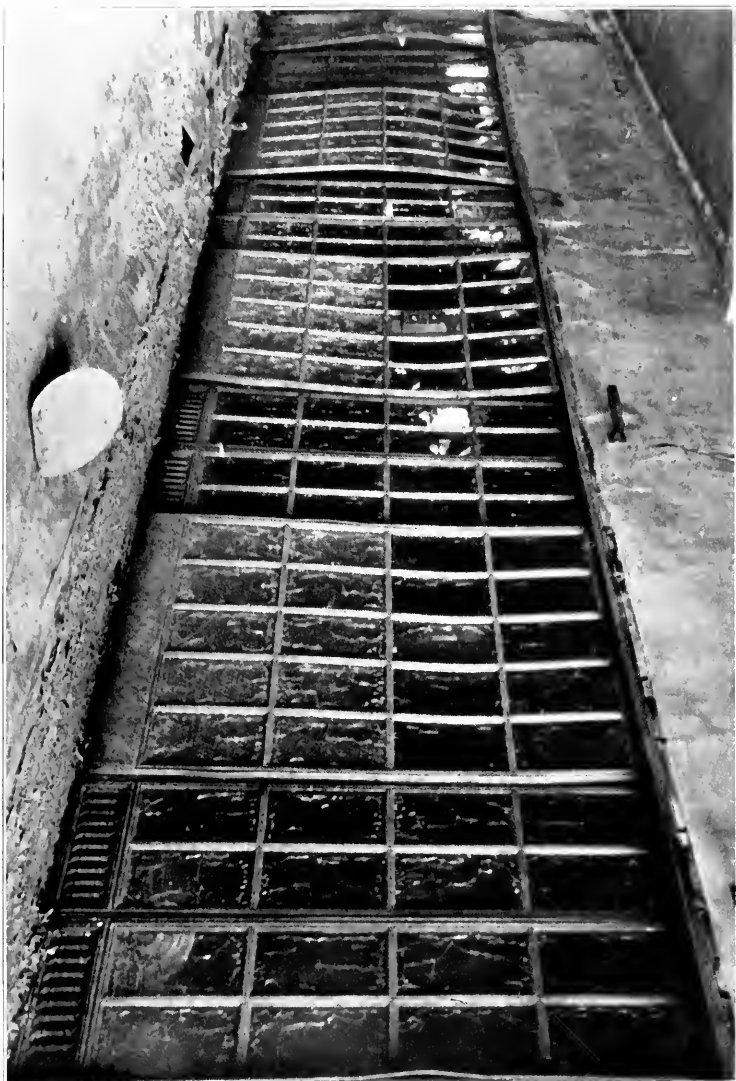
Marble flooring and wainscoting, principally in hallways, failed completely, partly from heat and partly from breakage.

Fig. 9.  
SHOWING FRONT WALL OF ONE BANK OF ELEVATORS, PERFORMANCE OF WIRED GLASS, AND  
DAMAGE TO MARBLE FLOOR.

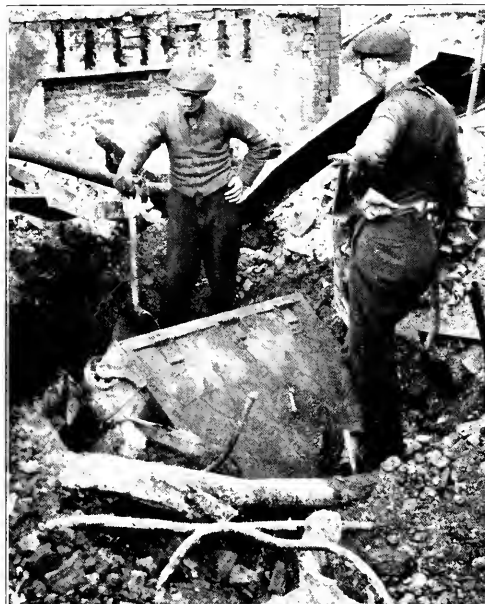
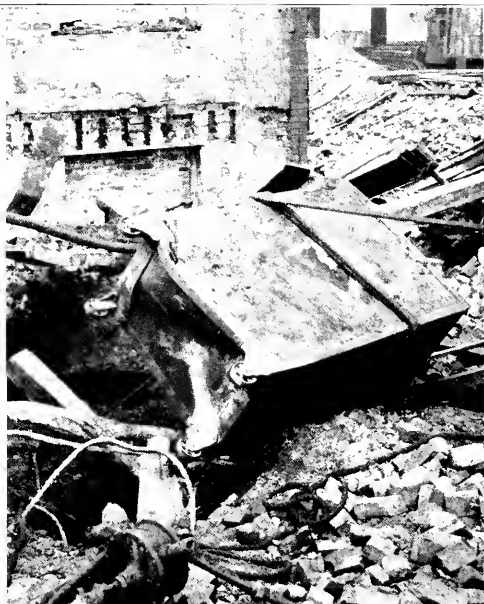
Fig. 10A.

(a) This safe was located on the 6th floor and was dug out of the ruins. See Fig. 10. Its appearance indicates that it was subjected to severe impacts as the angle-iron frame at the back had been badly bent by a blow and the weld between the vertical upright of this frame and the horizontal angle at the top was badly broken. It had also been subjected to severe blows on the frame at the bottom, as the angle-iron frame on this part was badly distorted. The whole frame at the front of the safe had bowed out considerably. The sheet steel forming the back of the member had become separated from the frame at the upper rear corner, presumably from the blow which the frame had received, and this separation extended some distance down the side, but the investigator was advised that some of this separation was due to prying done on the piece after the safe was recovered. The sheet metal forming one of the sides was badly buckled and showed evidence of having been subjected to severe blows. The metal at the top was bulged upward instead of downward, the usual distortion when the safe drops in an upright position. All metal indicated that the safe had been subjected to severe heat. There was evidently some passage

of heat to the interior of the safe as the asbestos packing of the joints was somewhat disintegrated, but this passage of heat was not sufficient to injure any of the contents. The interior appeared to be in a normal condition. The showing of the device under the conditions is considered very satisfactory.

LABELLED "B" SAFE BEING DUG OUT OF RUINS (LEFT). NOTE DAMAGE TO BOTTOM (RIGHT).  
THIS SAFE FELL FROM 6TH FLOOR.

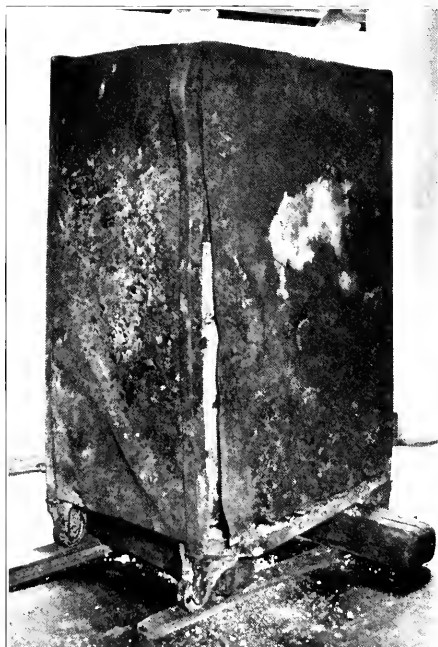
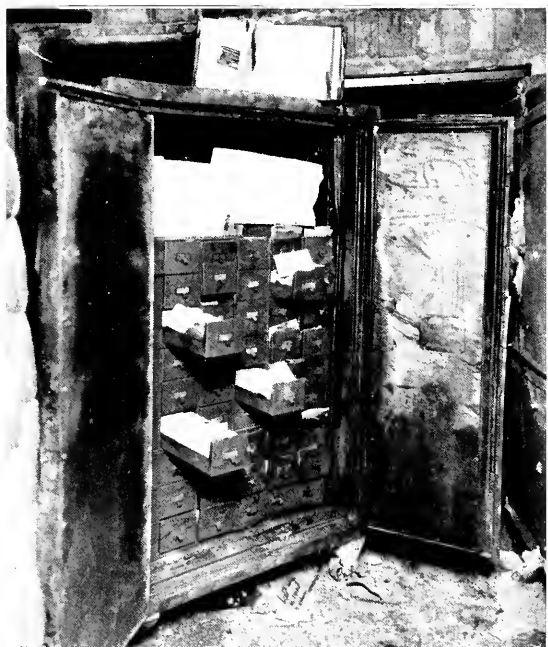
Fig. 10B.

SHOWING DAMAGE TO CORNER OF SAFE (SAME AS 10A), AND CONDITION OF CONTENTS.

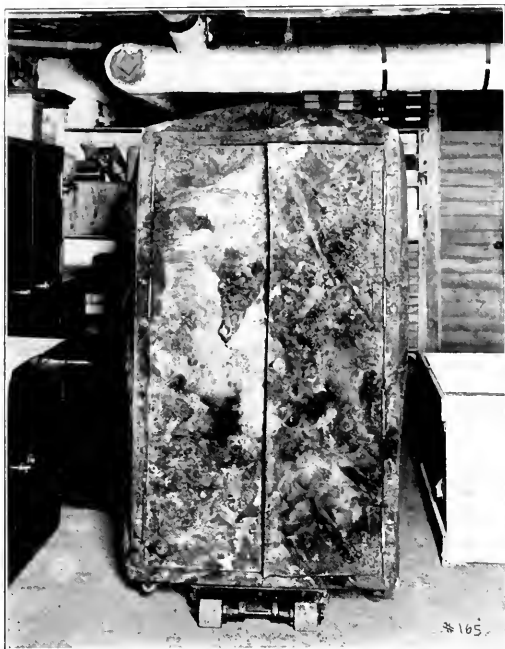
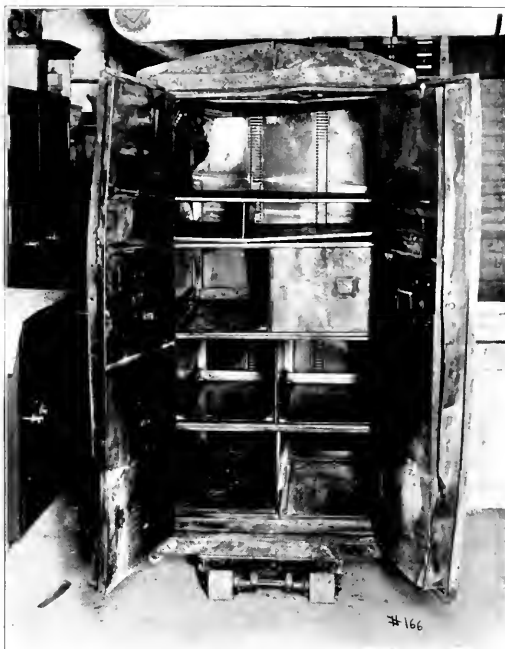
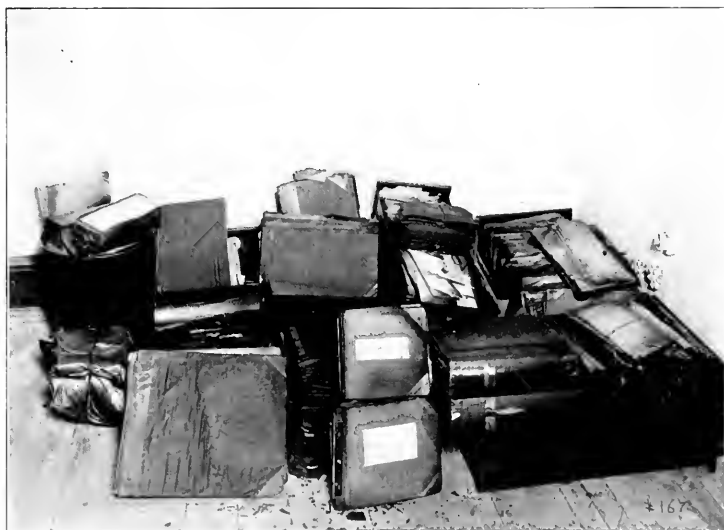
Falling from the third floor to basement, this safe was covered with heavy machinery and burning wreckage from several floors above. See Fig. 11. It had evidently been subjected to severe exposure, as the metal was burned on all sides, except the bottom, and the combination and one handle was melted off. Distortion of the metal also indicated that it had been subjected to severe blows. There was evidently considerable passage of flame at the joints, as noted by the condition of the paint. The owner reported that he was well satisfied with the protection afforded by this receptacle as the only material in the safe which was destroyed was the contents of one drawer which was of little value. There was some charring of the edges of other papers in the safe. It is believed that the penetration of heat into the interior was through the joint which was probably somewhat distorted by the blows to which the safe had been subjected. Credit is given the safe for resisting as much as could be expected of a device of its rating.

Fig. 11A. LABELED INSULATED CABINET WHICH FELL FROM 3D FLOOR.  
 Fig. 11B. SHOWING INTERIOR OF SAME CABINET, CONTENTS REMOVED.  
 Fig. 11C. CONTENTS REMOVED FROM CABINET 11A.
